The importance of moisture content in Pb-210 dating in sediments – Case study of the Fundão dam – Mariana (MG)

Abstract. The Fundão dam, in Mariana, broke in November 2015, releasing more than 59 million m³ of tailings that reached almost 700 kilometers along the river, crossing the states of Minas Gerais and Espírito Santo, reaching the estuary and reaching the Atlantic Ocean. After the accident, several environmental impacts were recorded along the path affected by the tailings mud. IBAMA requested a historical survey of contamination, due to the burial process, layer by layer of sediments. Because there are no bathymetric surveys, the changes that occurred in these places are unknown. To obtain this information, Pb-210 dating will be applied. In the present study, nine sediment cores were collected in different locations in the states of Minas Gerais and Espírito Santo. Based on the moisture profile, it was possible to identify the cores that had the potential to provide a Pb-210 profile that could be dated. After this analysis, three cores showed behavior within the expected range for Pb-210 dating.

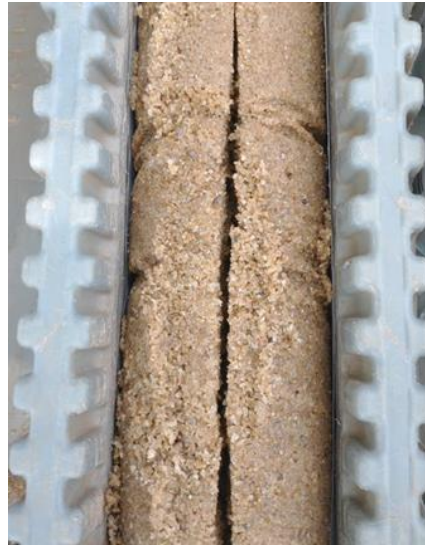
Figure 2. ERD profile composed only of sand.

As the ERD profile, from the Rio Doce estuary, was collected in a sand bank and because it only contains sand, the core was discarded because Pb-210 is present in the fine material. It is possible to observe the characteristic of this profile in figure 2.

Only the ERD profile was discarded before the analysis of the moisture profile, as it only contains sand. Based on the behavior of the moisture profiles, it was possible to identify the sediment cores that had the potential to provide a Pb-210 profile that could be dated. After analysis, three of the nine cores analyzed showed behavior, exponential, within the expected range for dating with Pb-210, namely: LNV, LAL and LAO. The BAG, AIM, MAS, LJP and ERD02 profiles were not considered due to water movement, thus avoiding the homogeneous deposition of sediments and the presence of bivalve.
